Maestría en Ciencia y Tecnología para la Sostenibilidad
Eje temático de Energía Renovable
Tesis de Maestría

Comparison of the effectiveness among different
photovoltaic fault detection techniques.

Solar panel failure detection by infrared UAS digital photogrammetry: a case study.

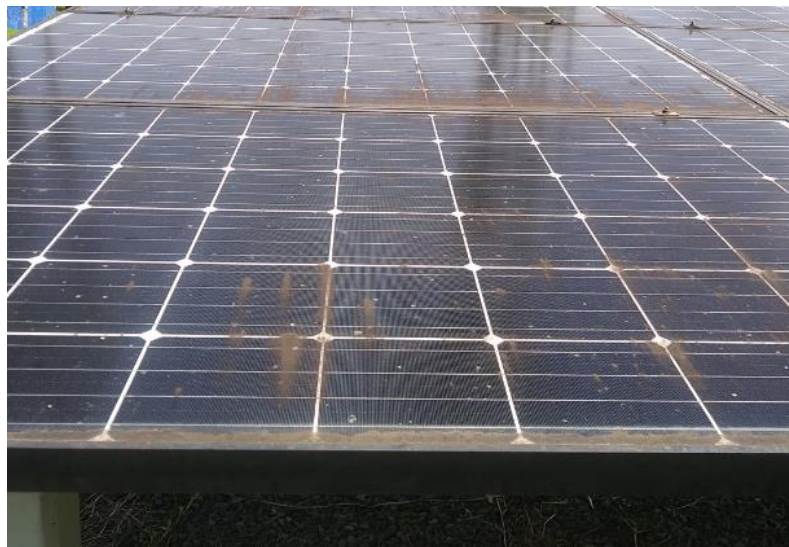
Fig. 3. Monocrystalline PV module used in this research for the evaluation of natural soiling. It is possible to observe the presence of non-uniform dirt.

Soiling due to leaves, bird drops, or patches of dirt, covering only a few cells of the PV module, generates non-uniform soiling. This has a severe power loss effect and is associated with both soiling and partial shading. PV cells that capture less irradiance will have a lower short circuit current than the rest, forcing the entire module to decrease its generated current and causing a hot spot to appear (Maghami et al., 2016). Fig. 3 shows a dirty solar panel that accumulated natural dirt distributed in non-uniform patches.

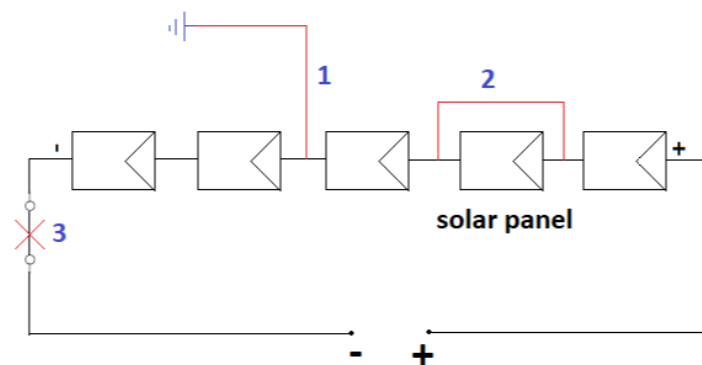
Fig. 5. Types of solar cell failures. 1) Short circuit to ground, 2) short circuit in a panel and 3) open circuit.

From the electrical point of view, the failures can be classified as follows, 1) ground faults, 2) faults between nodes, 3) open circuit faults, 4) others (Zhao, 2015). Faults cause a decrease in the power delivered and an increase in the temperature that varies according to the type of fault (Appiah et al., 2019; Chaudhary & and D.K. Chaturvedi, 2018; Tsanakas et al., 2016; Yadong Wang et al., 2016). The types of failures studied in this research are illustrated in Fig. 5.

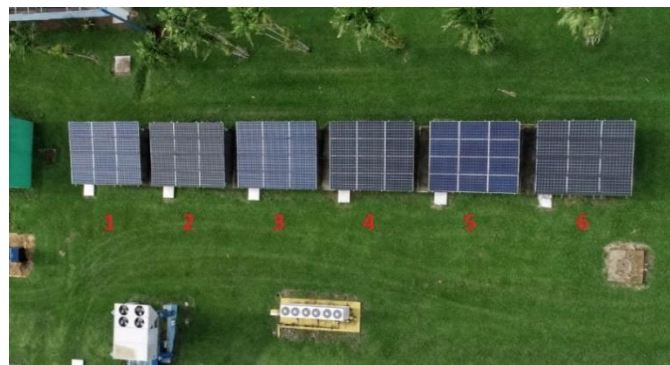
Fig. 6. Aerial photograph of the photovoltaic installation, where each string is identified.

- 1) Configuration: 72 panels distributed in 6 strings of 12 panels in series (see Fig. 6), with 3 monocrystalline and 3 polycrystalline strings.
- 2) Dimensions: The panels are 1650 mm x 992 mm and the strings are 4.95 m x 3.97 m.
- 3) Geolocation WGS-84: 10.361085, -84.509056.

An RGB picture taken with the drone is shown in Fig. 6.

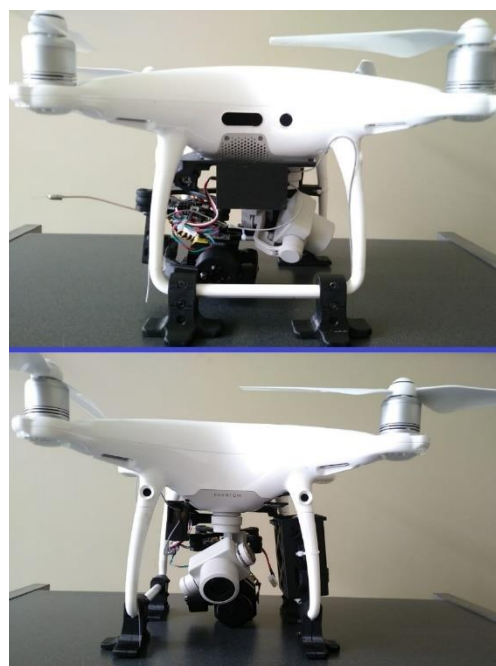
Fig. 7. Drone with RGB and thermal camera used in this work.

A commercial Phantom 4 Pro multirotor drone was the UAS platform, with a thermal camera attached. According to the manufacturer, the drone (see Fig. 7) weighs 1388 g and a flight time of 30 minutes without the thermographic system.

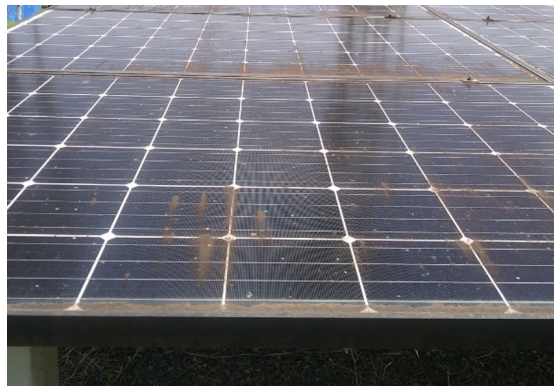
Fig. 2. Soiled PV module.

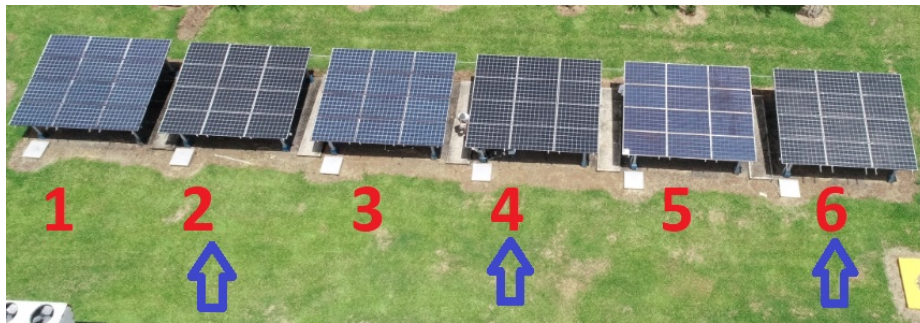
Fig. 3. Picture of the PV installation. Strings 2, 4 and 6 were used in this research.

Figure 3 shows an aerial view of the PV installation considered, where it can be seen that the site consists of six well distinguished sections. Each section has a string of 12 PV modules connected to an inverter SMA Sunny Boy 3000TL-US. In this analysis only strings 2, 4, and 6, shown in Fig. 3, were used. The aforementioned strings have a direct current STC power of 3380 W.

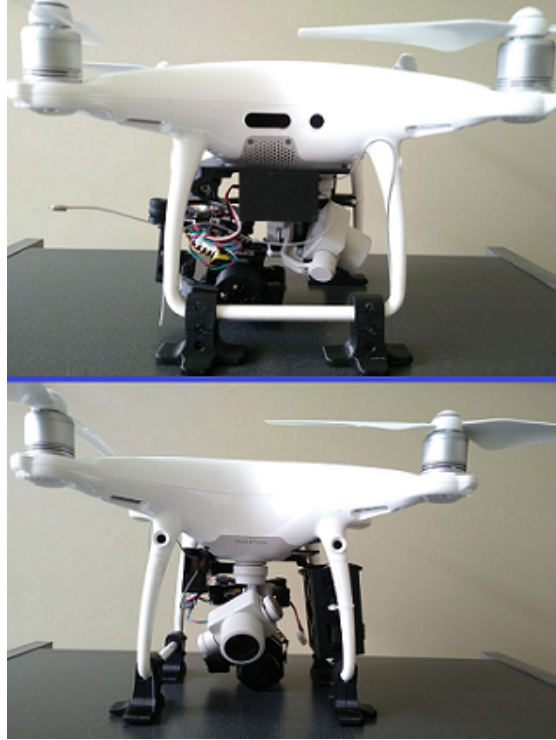
Fig. 5. Drone with RGB and thermal camera used in this research.

A commercial Phantom 4 Pro multirotor drone was used as the UAS platform (see Fig. 5). The characteristics of the RGB and thermal infrared camera are shown in Table 2 and 3, respectively.

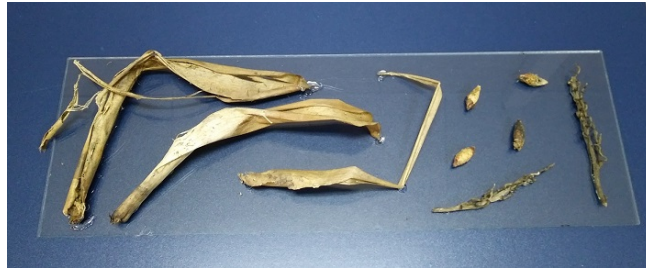
Fig. 8. Glass with dry leaves and seeds to simulate dirt obstructing the radiation path in three PV cells.

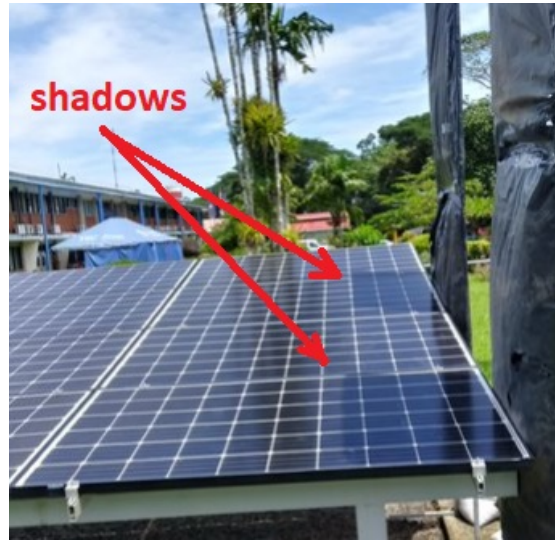
Fig. 9. Example of partial shadows generated on the PV modules.

The experiment was developed by applying shadows to the solar modules in operation. The methodology took as reference experiences of previous investigations, in which, they placed an object to obstruct the solar radiation of a portion of the solar module, allowing that it influences diffuse radiation [26]. The two partial shading levels (PS1 and PS2) applied were made by placing an object next to the PV string to create the shadow (Fig. 9).

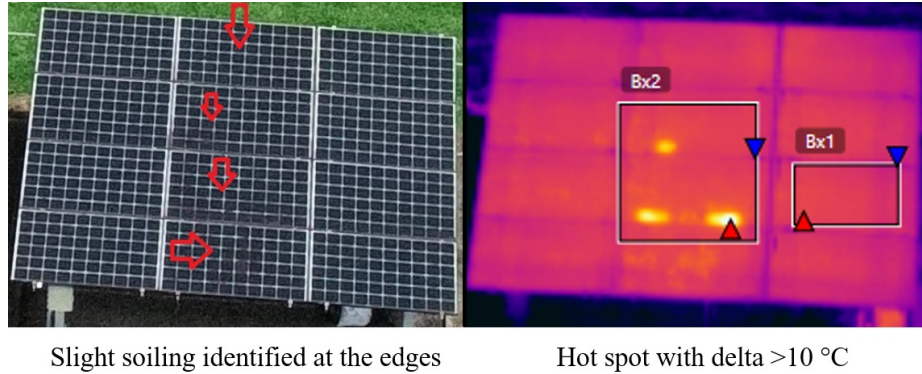
Fig. 10. RGB (left) and IR image (right) analyzed for experimental unit 1.

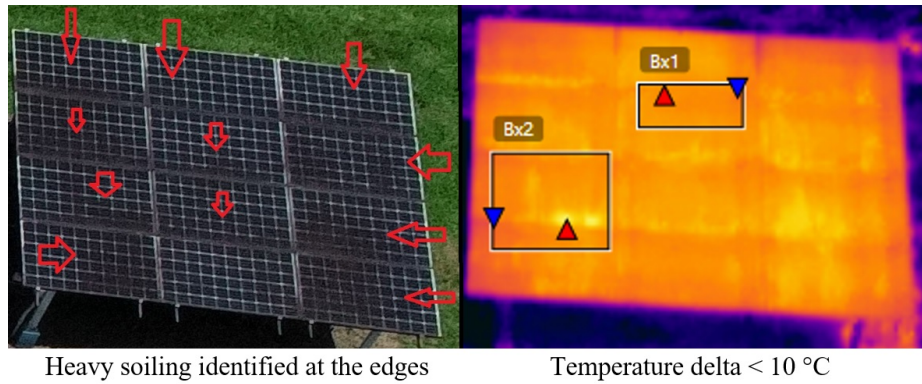
Fig. 11. RGB (left) and IR image (right) analyzed for experimental unit 2.

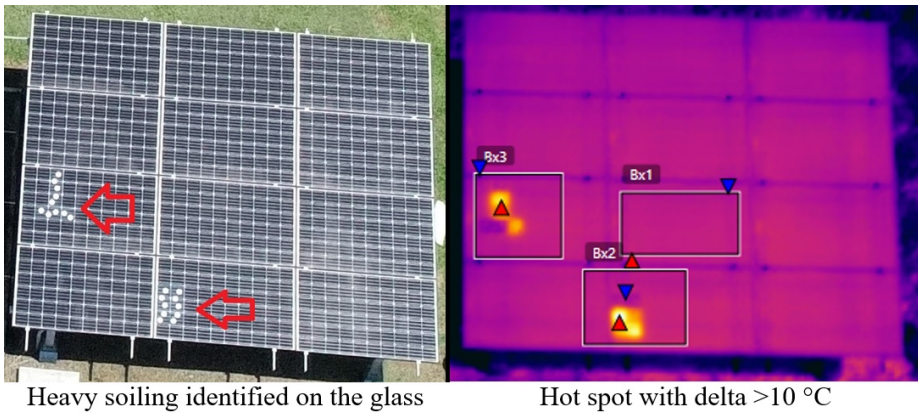
Fig. 13. RGB (left) and IR image (right) analyzed for experimental unit 18.

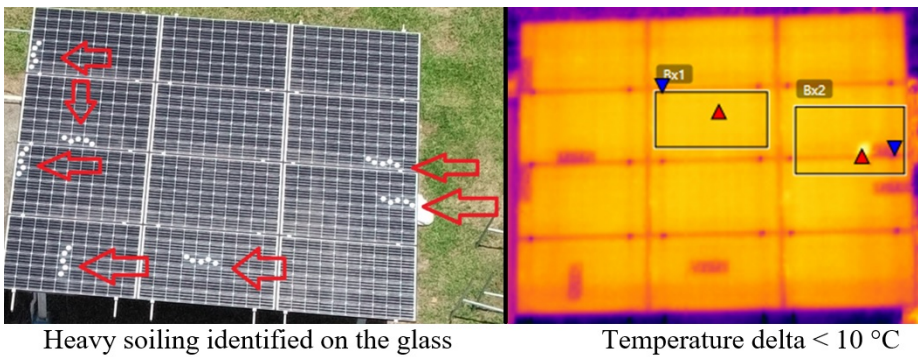
Fig. 14. RGB (left) and IR image (right) analyzed for experimental unit 19.

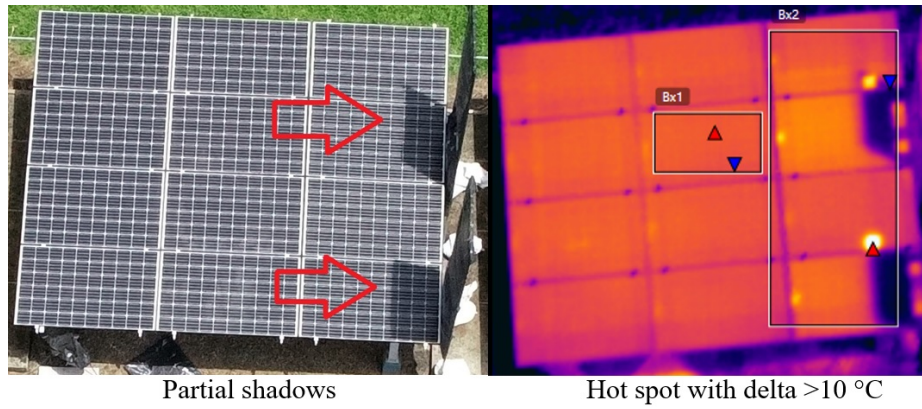
Fig. 15. RGB (left) and IR image (right) analyzed for experimental unit 22.

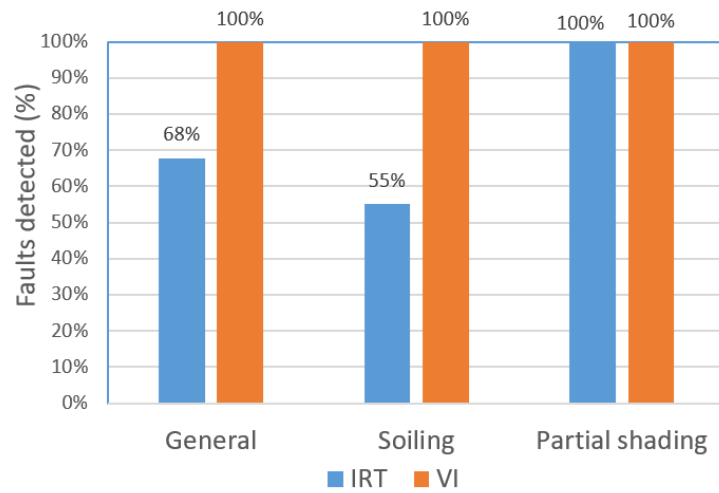
Fig. 16. Percentage of failures detected by each technique in the experiment.

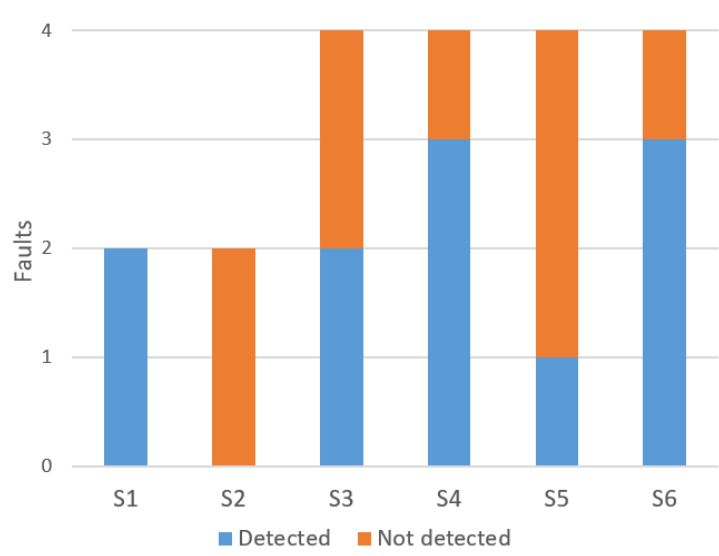
Fig. 17. Failures detected and not detected by the IRT under soiled conditions.

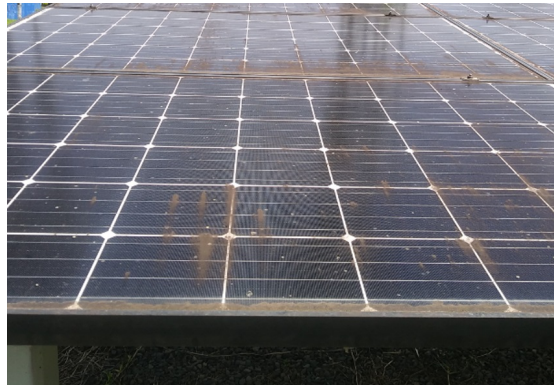
Fig. 2. Monocrystalline PV module analyzed with the presence of natural non-uniform dirt.

- Soiling: The presence of dust, leaves, dirt and generally any kind of dirt will cause a decrease in the power generated by a solar array, which will be greater as the amount of dirt increases [Maghami et al., 2016]. Uniform dirt (evenly distributed dust) [Javed et al., 2017] and non-uniform dirt (patches of dirt or bird drops) will have an affection on the power; the latter can also be classified as shading, since it creates a decrease in the irradiance that affects the PV panel, equivalent to a partial shade. The effect on the power due to non-uniform dirt causes a hot spot to be formed [Maghami et al., 2016]. Figure 2 shows a PV array with natural dirt, in which, non-uniform dirt can be observed.

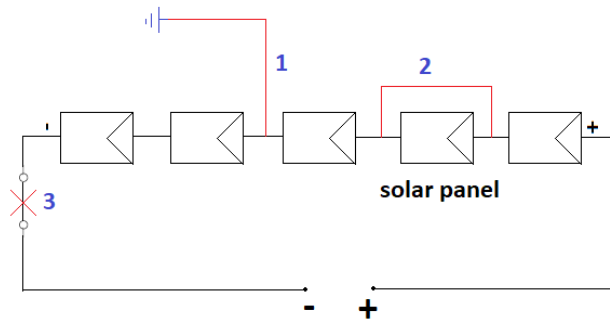
Fig. 3. Types of solar panel failures analyzed in this research. 1) Short circuit to ground, 2) Short circuit in panel and 3) Open circuit.

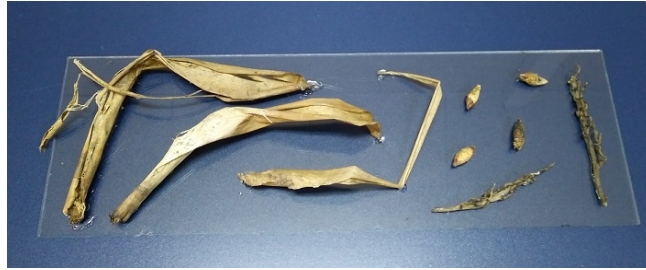
Fig. 8. Glass with dry leaves and seeds to simulate dirt obstructing the radiation path in three PV cells.

Faults S4 and S6 are a variation of S3 and S5 to evaluate soiling. In this case, dry leaves and seeds were used, where to achieve repeatability in the experiment the objects were adhered to the glass with cold silicon (see Fig. 8).

treatments S4 and S6 the glasses shown in Fig. 8 were used. The glasses used were 480mm x 160mm x 5mm.

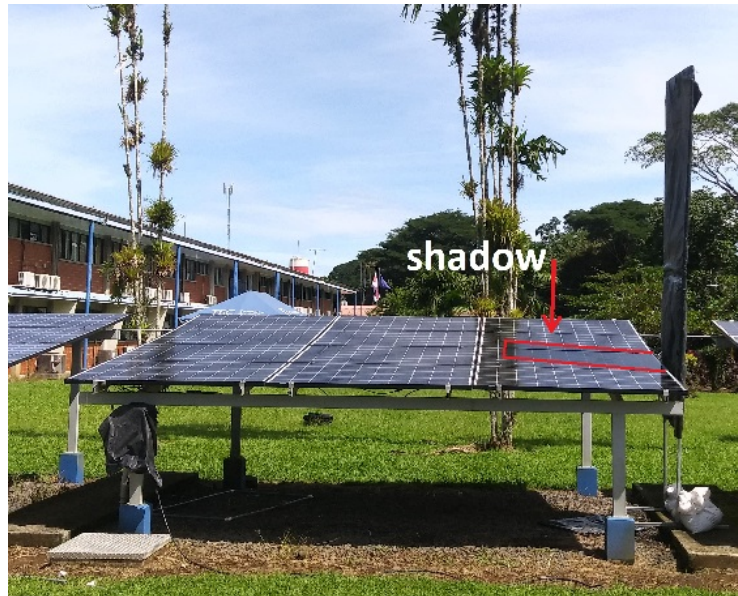
Fig. 9. Object used to generate the treatments of partial shade failures. The shadow generated corresponds to the PS1 treatment.

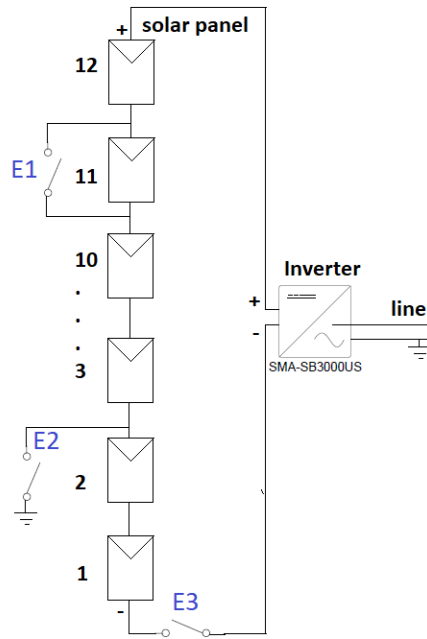
Fig. 10. Diagram of the location of the switches used to generate the electrical failure treatments evaluated in the experiment.

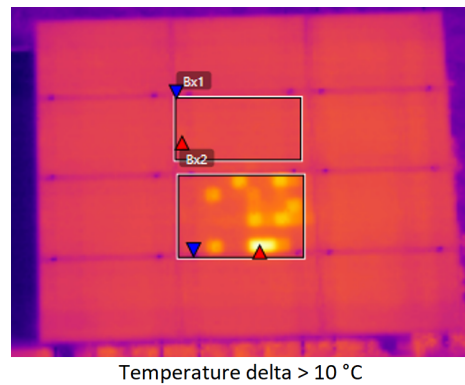
Fig. 11. IR image analyzed for the experimental unit 37. In this one, the heating generated in a solar panel due to the presence of a short circuit is observed.

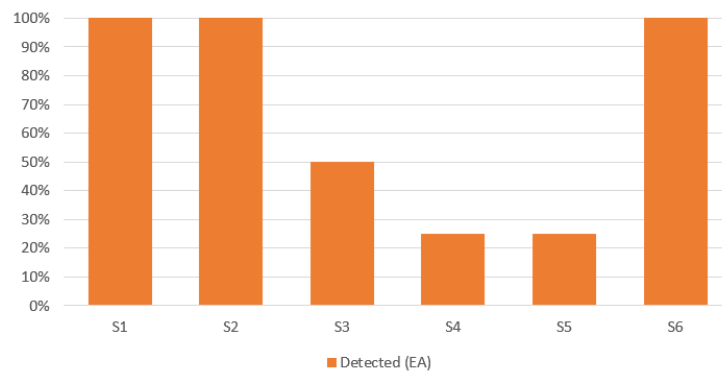
Fig. 16. Percentage of soiling failures that were detected by the EA. S1 and S2 were applied twice, the other four times.

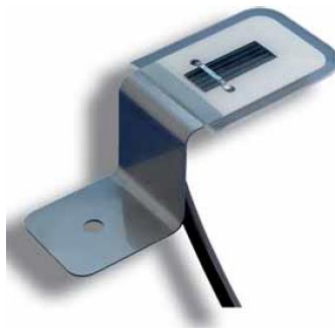
Fig 8. Photograph of the Spektron 2010 irradiance sensor used. Source: Manufacturer's sheet.

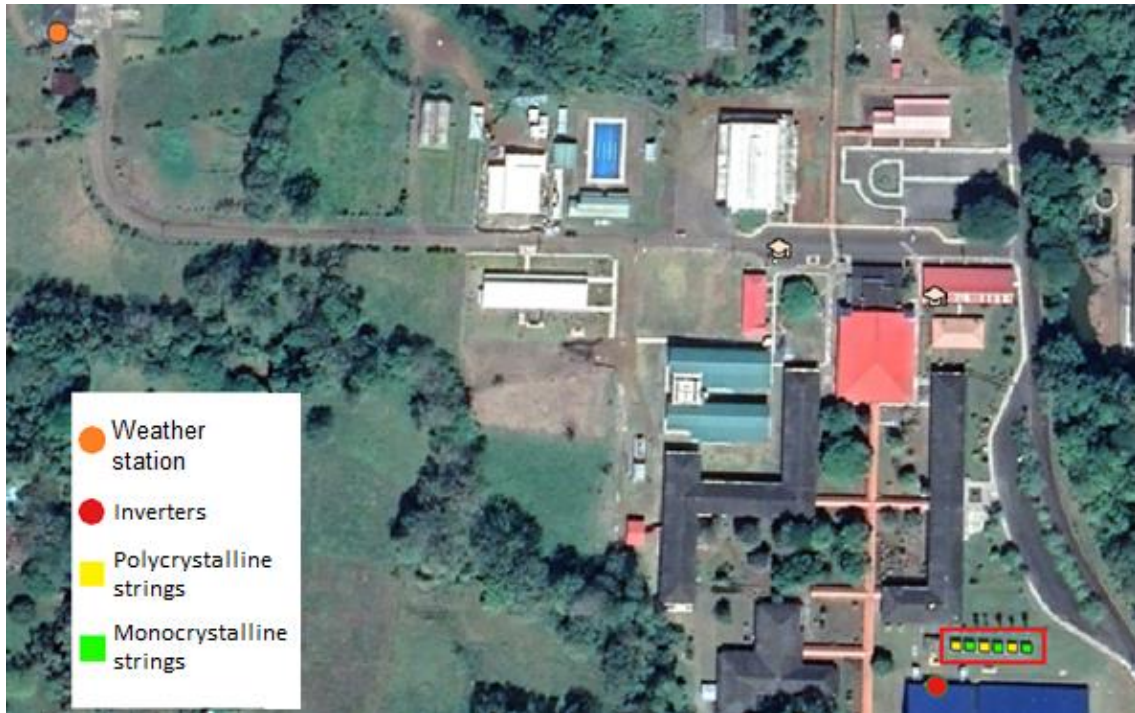
Fig 10. Aerial photograph with the location of the parts of the PV installation in San Carlos. The PV strings are enclosed in a red box. Image taken and adapted from Google Earth.

The TEC's PV installation is distributed between the technology campuses of Cartago and San Carlos (see Fig 9). The geographical distribution of the equipment of interest in this study is shown in Fig 10.
