Comparative Analysis of Traditional and UAV Bridge Inspections Performed by New Mexico State University

**ESCUELA DE INGENIERÍA EN CONSTRUCCIÓN
CONSTANCIA DE PRESENTACIÓN PÚBLICA DEL PROYECTO DE GRADUACIÓN**

Proyecto de Graduación presentado públicamente ante el Tribunal Evaluador el lunes 11 de setiembre de 2023 como requisito parcial para optar por el grado de Licenciatura en Ingeniería en Construcción, del Instituto Tecnológico de Costa Rica.

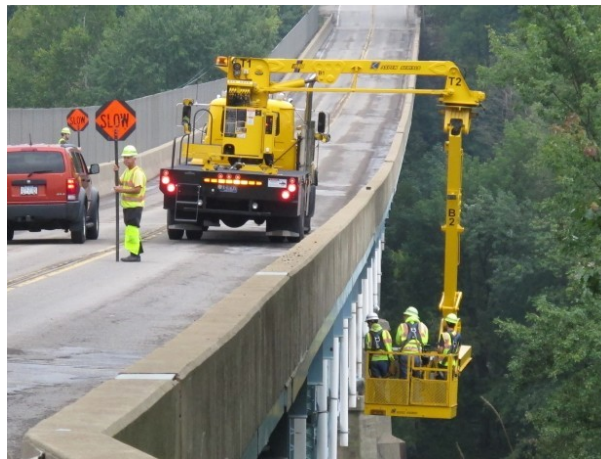
Figure 1. Traffic control due to a UBIT inspection.

Another problem that the use of UBIT implies is the economic losses caused by traffic stoppage, in which both merchandise and employees will have to spend more time to reach their destinations, according to the New York Times, these losses represent more than \$100 billion a year [12]. An example of the vehicle control required for the use of UBIT is shown in Figure 1.

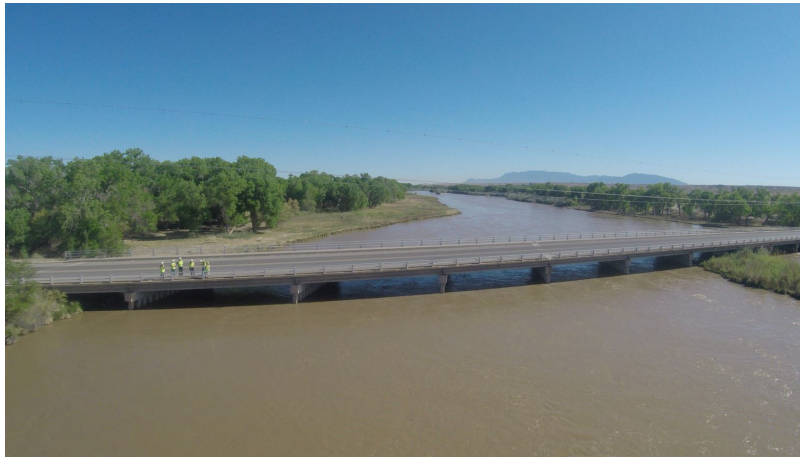
Figure 5. Bridge 7510 profile view looking North.

Based on the considerations outlined in Chart 2 in Chapter 2, Bridge N° 7510 was selected as a sample bridge. Visual evidence that the surrounding area met the specified requirements can be seen in Figures 5 and 6. This ample space provided the UAV pilot with enhanced mobility along the bridge, as there were no significant hazards obstructing the flight path and risking collision. In addition, the bridge had unobstructed access to the abutments, as the presence of minimal vegetation did not impede the UAV's passage through the spans near the abutments. The bridge's location in a rural area had minimal impact on nearby traffic. This made it easy for the inspectors to mobilize along the deck.

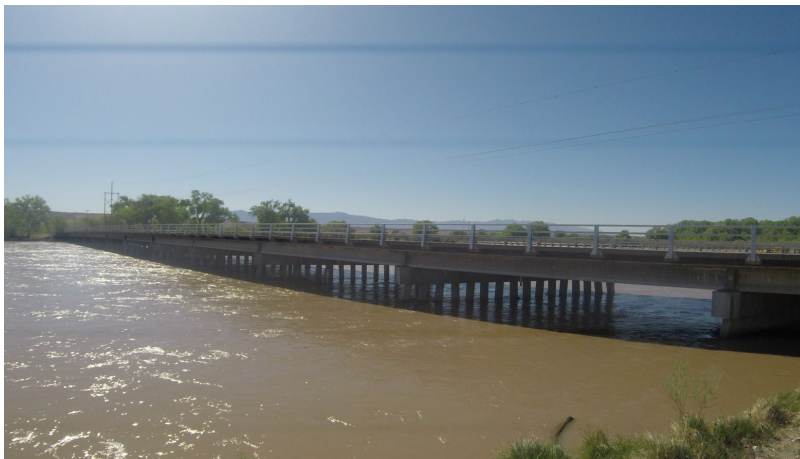
Figure 6. Bridge 7510 profile view looking South.

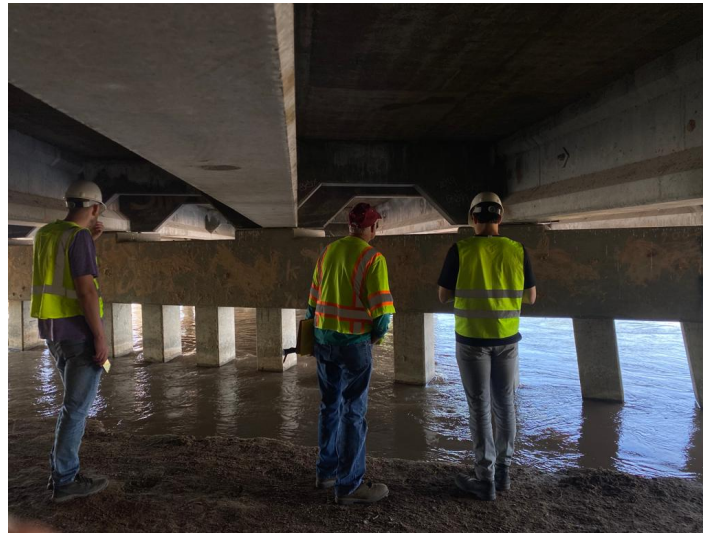
Figure 7. Team A inspecting accessible spans.

Productivity measurements began a day before the inspection day with a review of previous reports. Upon arrival at the site, inspection of the superstructure and wear surface from Abutment 1 to Abutment 2 began. Then the substructure was inspected. Due to lack of access to all spans, only spans 1 and 12 were inspected as shown in Figure 7. In the end, the team went back to the office and prepared the report with the quantification of the damage that was observed. Table 1 shows the summary of the quantification of the condition of the elements: deck, girders, abutments, pile caps and piles. LEAN productivity measurements were taken throughout all of these processes.

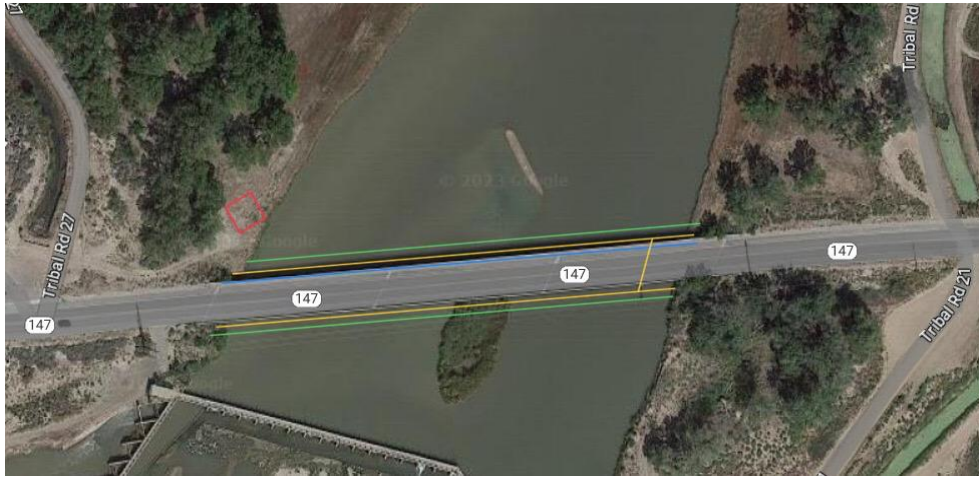
Figure 9. On-site flight planning.

As with the traditional inspection, the UAV-assisted inspection began with a review of previous reports. Before the inspection day, on-site flight planning was conducted to determine the launch zones, the number of flights, the flight path, and the practice flight. It also included the logistics of the drone flight, such as the definition of the marking zones and the application for the flight permit. Figure 9 details the pre-planning for the inspection. The red color is the launch area used, the green color was used to highlight the path of the first and third flights. Blue was used to highlight the second flight path, and yellow shows the flight through the substructure.

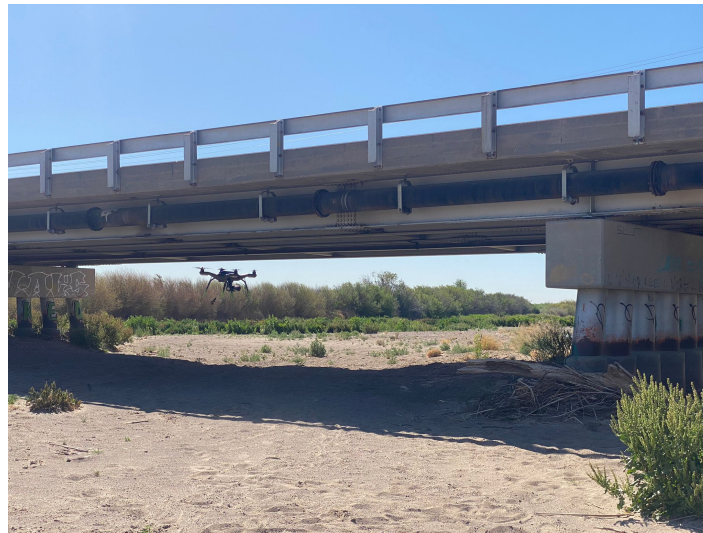
Figure 10. UAV flying through the spans during practice flight.

Conducting practice flights was an integral part of the process, allowing the inspectors to verify the proper functioning of the UAV and test the planned flight paths. The test flight was conducted on a bridge with similar characteristics. The absence of water during the flight made it easier to manipulate the UAV through the spans as observed in Figure 10. In particular, the test flight revealed a new threat to flight operations, namely the transit of wild animals. During the test flight, a group of birds began to fly in close proximity to the UAV, intermittently disrupting its flight. In response to this situation, measures were taken to anticipate such occurrences during the inspection, including the decision to procure an air horn to scare off the birds should they appear on the day of the inspection.

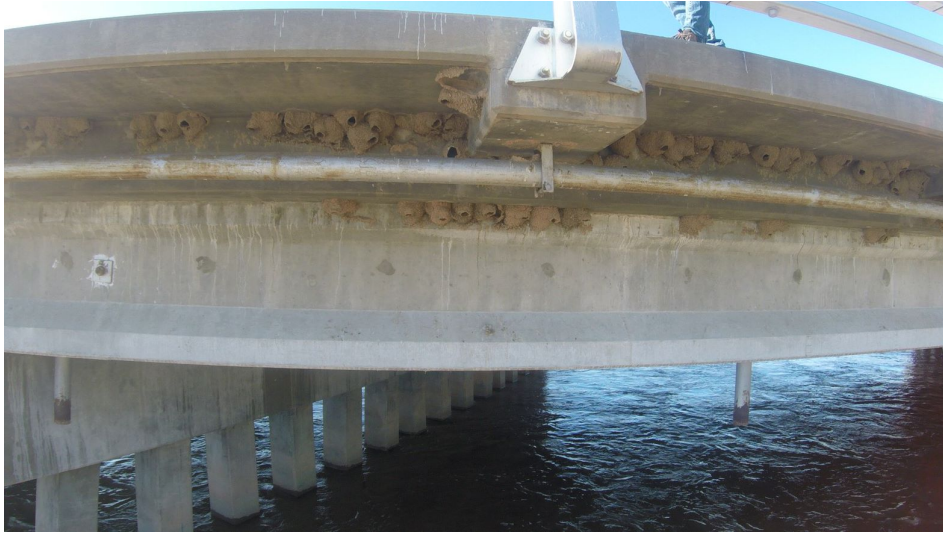
Figure 11. Deck-side and outer girder on South view.

Four flights were made on the day of the inspection. The first and third flights were made along the south and north sides of the bridge, the flights were at deck level to observe the cracking behavior at the deck edges and to observe the exterior girders as shown in Figure 11 and 12. The second flight focused on observing the deck from an oblique top view as shown in Figure 13.

The four flights conducted on the day of the inspection proved to be successful, providing valuable insights into the condition of elements that were previously inaccessible during the traditional inspection. The first and third flights yielded significant observations regarding the behavior of cracks along the edges of the deck, highlighting their propagation or concentration patterns along the deck and offering insights into the condition of the exterior girders, as depicted in Figures 11 and 12.

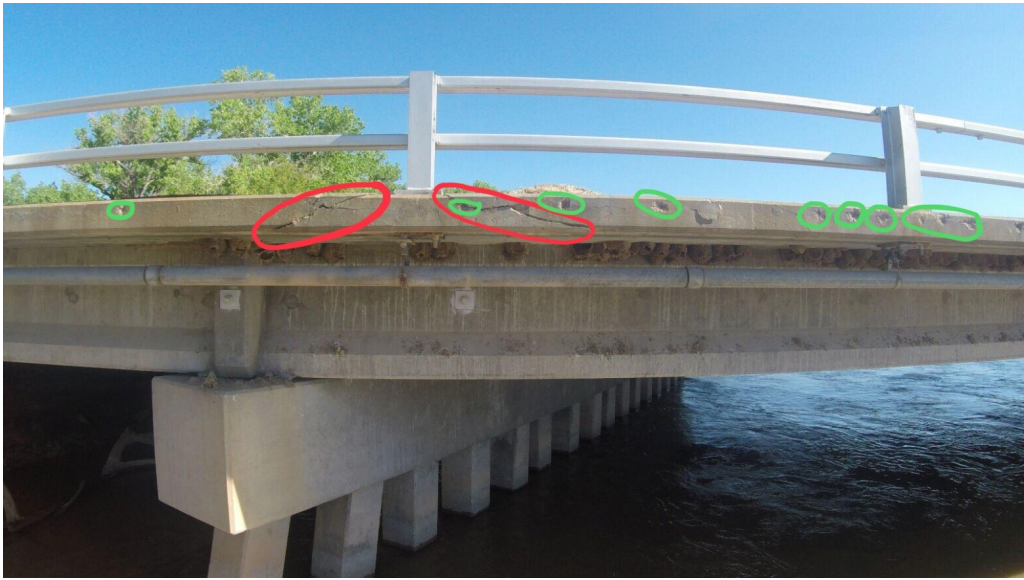
Figure 12. Cracks on deck-side and outer girder on North view.

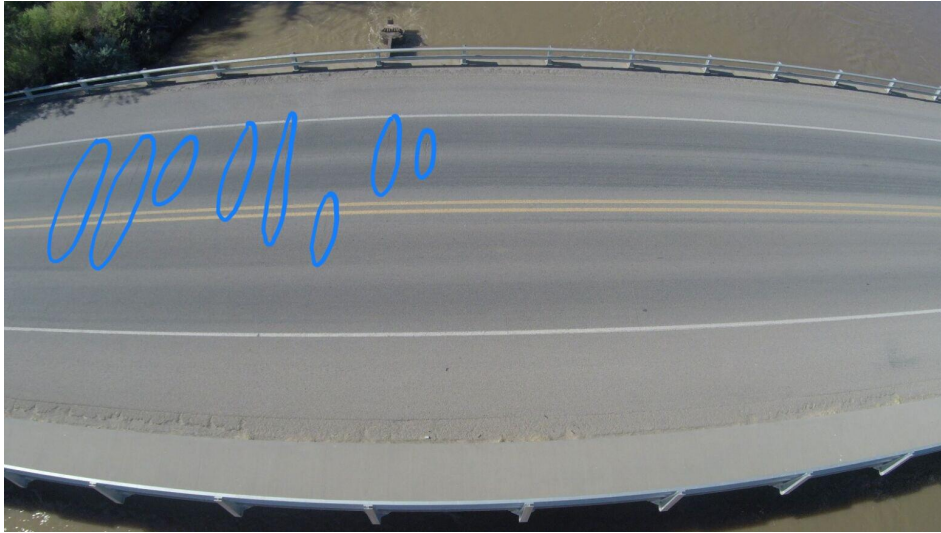
Figure 13. Transversal cracks on deck identified during the second flight.

Despite having access to the deck during the traditional inspection, it was considered necessary to make a second flight specifically to obtain oblique photographs. This type of photography allows for the identification of crack patterns that may indicate the presence of map cracking, which is critical to a full understanding of the structural condition.

Upon completing the traditional inspection and assessing the remaining elements, the quantification of damages was conducted for the deck, girders, abutments, pile cap, and piles. With regards to the deck, the observations made during flights one and three provided valuable insights into the behavior of cracks along the edges. The damages depicted in Figures 11 and 12 allowed for the assignment of a condition state (CS) of 3 (Poor) to the deck due to the presence of wide cracks.

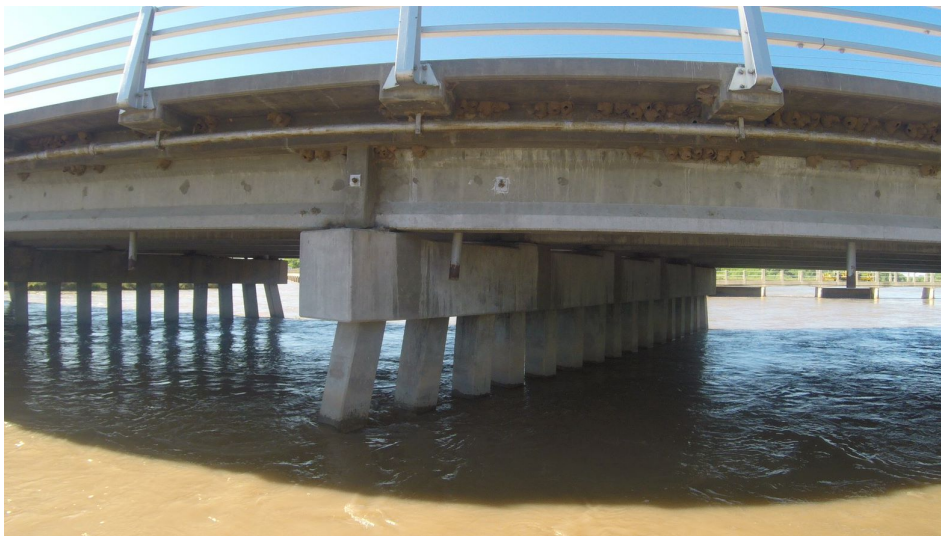
Figure 14. Closement to the span near abutment 2.

The last trip focused on observing the substructure, the UAV flew at the lowest possible height without touching the water and without colliding with the girders to enter the span, in Figure 14 is possible to see the view from the drone before entering the span. The condition of Spans 2-11, which could not be observed during the traditional inspection, was observed during this flight. The observations were limited to the visual detection of any cracks or spalling.
